Monumental Brass Society

CARE AND CONSERVATION
OF BRASSES AND SLABS

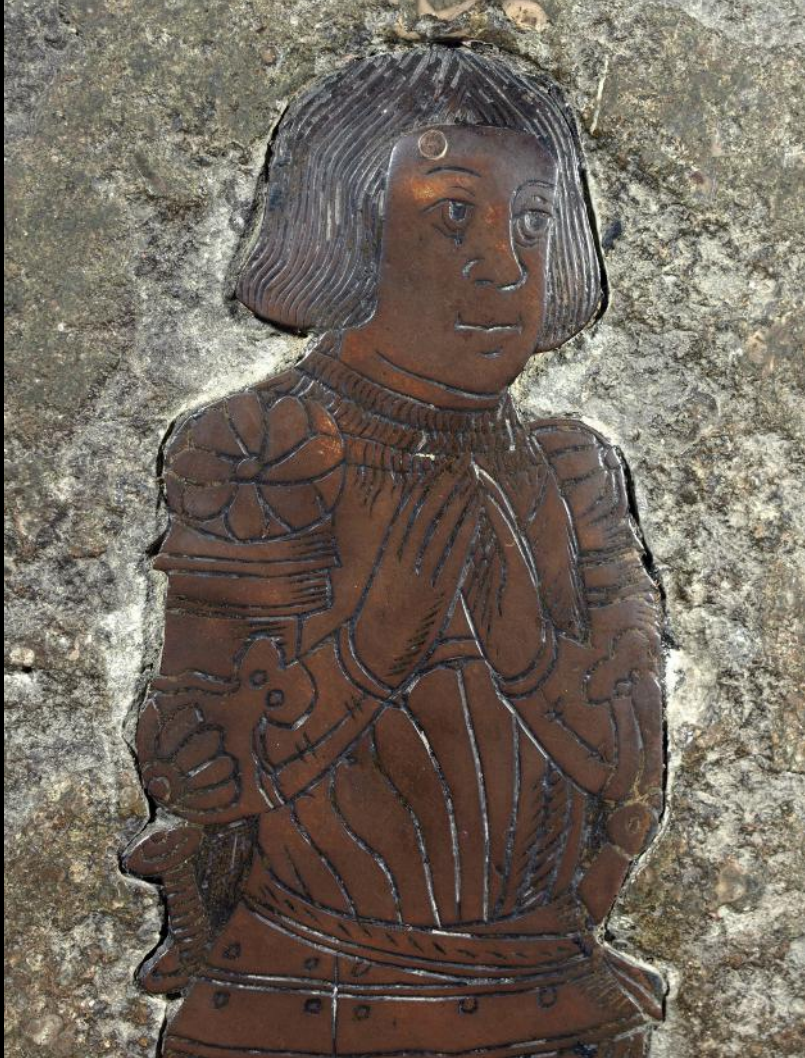
*Cover: Detail from brass to Richard Radclyffe, 1472,
at Middleton, Lancashire conserved by William Lack in 2004.*
